ARTICLE

Effect of hydrogen on the integrity of aluminium–oxide interface at elevated temperatures

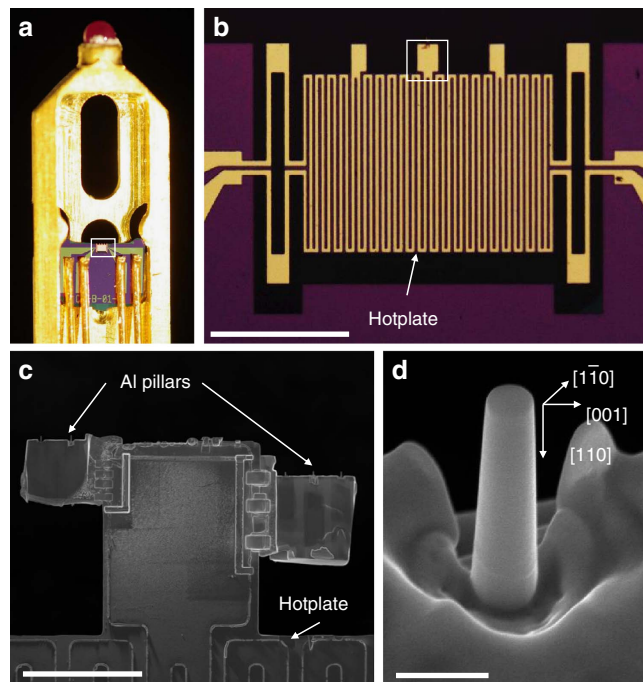
Figure 1 | Experimental setup and sample information. (a) Optical image of the front end of the TEM specimen holder with a home-made MEMS heating chip mounted inside. (b) Enlarged view of the area indicated by white rectangle in (a) showing the heating/sensing traces and sample mounting bars in the hotplate of the MEMS heating chip. (c) SEM image of the sample-mounting area as outlined by a white square in (b) with two lift-out aluminium plates attached at both sides. The Al pillars are directly fabricated on the Al plates using FIB. (d) SEM image of a typical FIBed pillar viewed from 45°. The pillar is ~250 nm in diameter with an axial direction of [110]. The pillar is viewed from the [110] direction in TEM. Scale bar: (b) 200 μm, (c) 30 μm, (d) 500 nm.

Hydrogen induced formation of giant cavity. Two separate groups of pillar samples were fabricated via focused ion beam (FIB) micromachining, each on an aluminium plate attached to the hotplate of the MEMS heating chip using FIB lift-out process (Fig. 1 and Supplementary Note 1). The nominal crystal orientation and size of these pillars were identical. One group of samples was first hydrogenated inside the ETEM with 2 Pa H₂ at room temperature (20 °C) using the method introduced in our previous work²⁸. The hydrogen source was cut off when very small Wulff construction-shaped cavities ($R \sim 5$ nm, referred to as

Sample preparation. Single-crystalline aluminium (99.9995%) disks were cut into 1.5×2 mm² rectangular plates and mechanically polished on one surface. Then, $\sim 30 \times 30$ μm² lamellas with a thickness of 3 μm were fabricated using FIB (FEI Helios 600, operating at 30 kV) and transferred to the freestanding end of the home-made MEMS heating chip in Fig. 1 using the FIB lift-out process.

In situ TEM experiment. Hydrogenation and heating were carried out *in situ* in the differentially pumped Hitachi H-9500 ETEM operating at 300 keV with the home-made MEMS-based ultra-stable heating holder shown in Fig. 1a. The ETEM was evacuated to a base vacuum of 10^{-4} Pa.

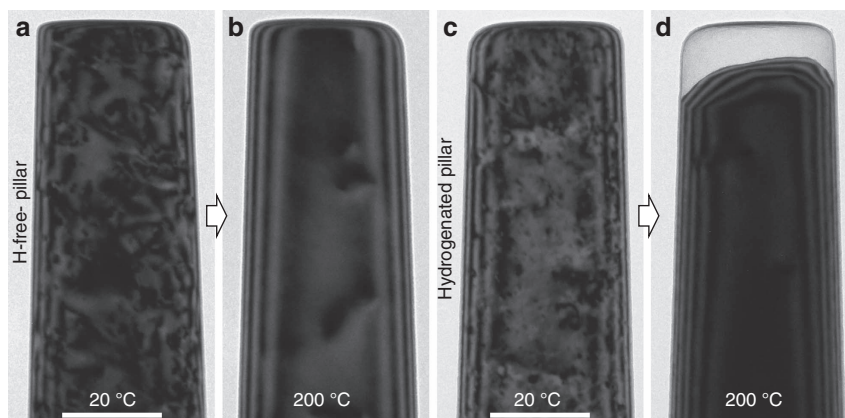
Figure 2 | Comparison of heating effect on hydrogen-free and hydrogenated pillars. (a,b) The morphological change of a hydrogen-free pillar. At room temperature (a), the interior of the pillar shows high density of dislocations that are annealed out after heating up to 200 °C (b). After heating, a clean interior and smooth thickness contours are observed. (c,d) The morphological change of a hydrogenated pillar. Besides annealing, a giant cavity formed at the top of the pillar. Scale bar, 200 nm.

After heating to 200 °C, giant cavities with detached oxide shell and naked-metal surface were observed to form in hydrogenated pillars but not in hydrogen-free pillars (see Fig. 2). Before heating, both the hydrogen-free pillar (Fig. 2a) and the hydrogenated pillar (Fig. 2c) contained a high density of long dislocation lines and dislocation loops. After the samples were heated to 200 °C, nearly all of these dislocations were annealed out from both samples, as evidenced by the nearly perfect thickness contours inside the pillars (Fig. 2b,d). However, within the hydrogenated pillar, a giant cavity of $\sim 300\text{ nm}$ in size was observed to form via retreat of the naked-metal surface at the front end of the pillar, leaving behind a neat hollow oxide shell (Fig. 2d).

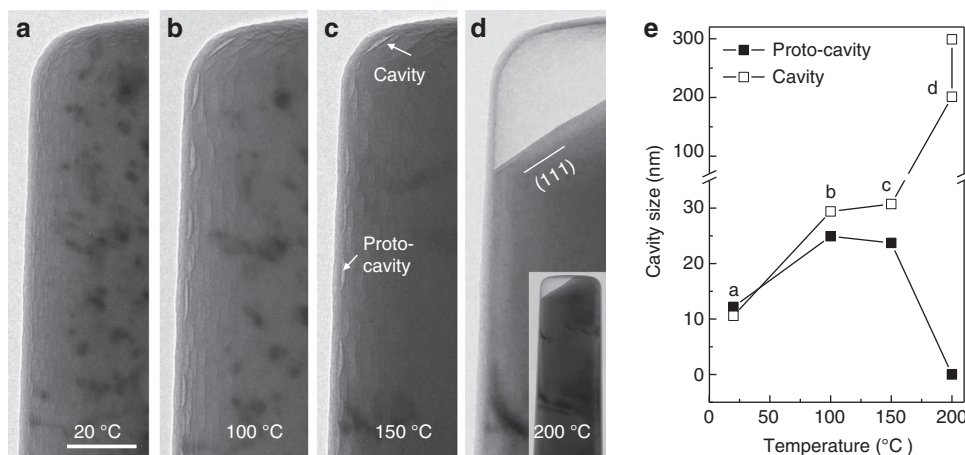
Figure 3 | Formation of a typical giant cavity at $\text{AlO}_x\text{-Al}$ interface. See the Supplementary Movie for the dynamic process. (a–d) Snapshots of the pillar at 20, 100, 150 and 200 °C, respectively. (e) Size evolution of the proto-cavities and cavity with temperature. From 20 to 100 °C, the proto-cavities grow, but as the cavity on the corner begins to grow, the proto-cavities decrease in size. Scale bar, 100 nm.

Cavity evolution process. Figure 3 and the Supplementary Movie show the development of proto-cavities in the hydrogenated pillar with increasing temperature (see Supplementary Fig. 1 for snapshots of the Supplementary Movie). Figure 3a–d are the top left side of the pillar at 20, 100, 150 and 200 °C, respectively. At 20 °C, the proto-cavities show a homogenous distribution at the oxide–metal interface, with an average diameter of $\sim 10\text{ nm}$. In the ensuing heating-up process, the evolution of these cavities can be divided into three stages. (1) Before reaching 100 °C, some proto-cavities grow by coalescing with neighbouring proto-cavities (Fig. 3a,b and Supplementary Fig. 1b,c) with a mechanism similar to Ostwald ripening. (2) Between 100 and 150 °C, the size of most cavities remains largely unchanged or even slightly decreases, while a few bigger ones continue to increase in size slightly (Fig. 3c and Supplementary Fig. 1d). (3) Between 150 and 200 °C, nearly all proto-cavities decrease in size until they eventually disappear, while one proto-cavity at the free end of the pillar develops into a giant cavity (Fig. 3d and Supplementary Fig. 1e,f). The formation of this giant cavity is also similar to Ostwald ripening, although it happens over a greater distance than that in the proto-cavity growth in stage 1, by absorbing proto-cavities

located within micrometres distance. The size evolution of a proto-cavity (solid square) and the giant cavity (hollow square) versus temperature/time are plotted in Fig. 3e that clearly shows the divergence of size change after a critical temperature (T_c) of 150 °C, likely because after reaching T_c , the large-scale coalescence of cavities becomes possible via long-range diffusion pathways, following the ripening of proto-cavities before reaching T_c , when connections between neighbouring detached areas formed.

In the early stage of giant cavity formation, the metal surface usually shows low-energy surface facets of {111} (Fig. 3d), indicating a surface diffusion-mediated cavity evolution (see Supplementary Fig. 4 and Supplementary Note 3). At room temperature, surface diffusion mainly occurs locally, but at higher temperatures, surface diffusion becomes effective across longer distances, enabling the coalescence of numerous proto-cavities into a few giant cavities. This long-range surface diffusion at high temperature may be activated by the following two processes: on one hand, the growth and initial coalescence of proto-cavities connect more and more detached interfacial areas (Fig. 3b,c), opening up a long-range fast diffusion pathway. On the other hand, the temperature rise drives more dissolved hydrogen and supersaturated vacancies out of the substrate. When these effusing vacancies are absorbed by the interface, they will break more interfacial bonds and detach more metal–oxide interface that further boosts the interfacial/surface diffusion under the oxide shell. To verify the latter argument, we aged some hydrogenated samples in vacuum at room temperature for 12 h to effuse the hydrogen and therefore reduce the number of hydrogen-vacancy complexes significantly. After ageing, the interfacial proto-cavities remained unchanged and heating thereafter to 200 °C resulted in a similar disappearance of proto-cavities, but no giant cavity form (see Supplementary Fig. 5). What happened instead was the previously detached oxide layer re-bonded with the naked metal to remove the proto-cavities, and

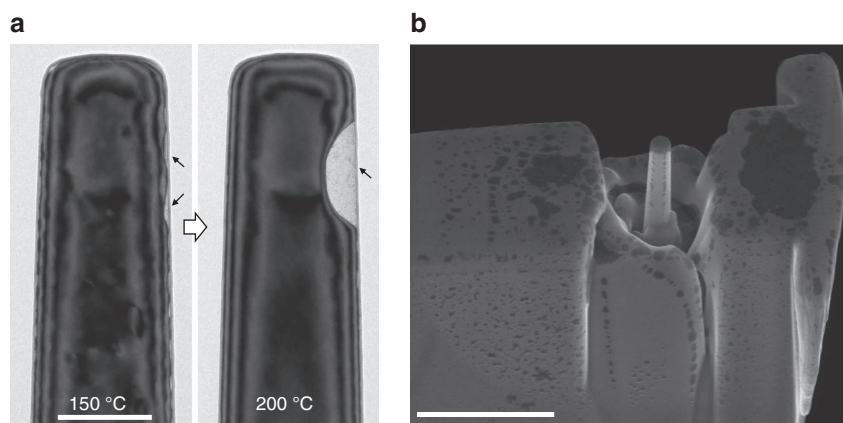
Figure 4 | Distribution of giant cavities on sample surface. (a) Formation of a giant cavity at the same location as the largest proto-cavities at the side of the pillar, as marked by the arrows. (b) SEM image viewed from 45° of a larger sample area after the same hydrogenation and heating treatments. Giant cavities not only formed at the top of the pillar, but also at the plane surface of the plate. Scale bar: (a) 200 nm, (b) 2 μm.

Distribution of cavities. Giant cavities can be found in many sites of the hydrogenated volume, as shown in Fig. 4. Note that the two cavities marked with black arrows in Fig. 4a (left side of panel) are each larger than those along the top surface of the pillar. Also note that after heating up to 200 °C, these cavities coalesced, developing into a giant cavity along the side of the pillar, while the cavities along at all the other sites became refilled (Fig. 4a, right side of panel). By accident, we found the second electron image collected by through-lens detector (TLD) are surprisingly effective in detecting the buried cavities. Figure 4b shows a typical scanning electron microscopy (SEM) image of the hydrogenated-and-heated sample taken with the TLD, in which giant cavities (dark contrast areas) can be found in several places at the plane surfaces and at the pillar top, with one

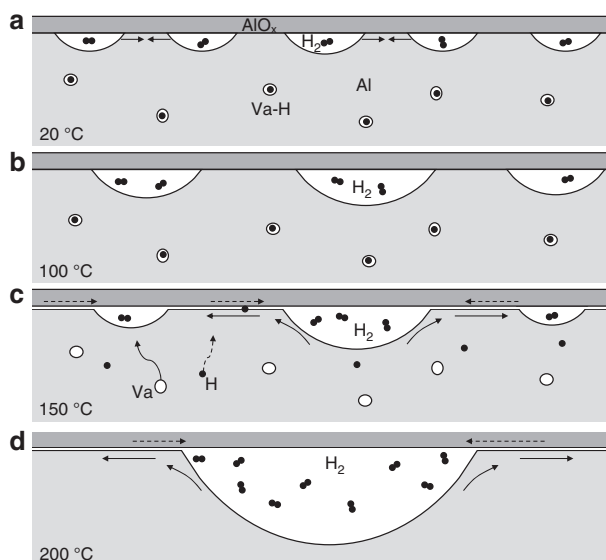
Figure 5 | Schematic illustration of the formation of giant cavities in hydrogenated metals during heating. (a) At room temperature, the hydrogenated metals have gas-filled proto-cavities under the oxide layer and hydrogenated vacancies in the bulk. (b) From 20 to 100 °C, the proto-cavities coalesce to grow bigger. (c) From 100 to 150 °C, the hydrogenated vacancies tend to dissociate due to the thermal destabilization. Both interstitial hydrogen and naked vacancies are freed to diffuse outwards. As a result, the metal–oxide interface becomes further weakened, opening up a diffusion highway for surface diffusion and H₂ flow under the oxide layer. The diffusion pathways of Al and H₂ are marked with solid and dashed arrows, respectively. (d) At 200 °C, a giant cavity is formed where the biggest proto-cavities was found.

Hydrogen damage of passivated metal surfaces at high temperatures can be summarized as the four-step process shown in Fig. 5. Step 1, during hydrogenation at room temperature, due to the low solubility of hydrogen in aluminium at room temperature⁴², hydrogen mainly segregates at defective traps such as vacancies and the metal–oxide interface. By reducing the ideal work of interface separation^{5,43}, the confinement of oxide shell on the metal matrix is weakened that further promotes the surface-diffusion-driven cavitation under the metal–oxide interface. Since the segregated hydrogen atoms at interface have chance to meet and recombine, the produced hydrogen molecules will fill into those cavities. The above formation process of gas-filled cavities has been detailed in our previous work²⁸. Besides, by trapping hydrogen atoms, vacancies in the bulk are stabilized at $T < 150$ °C and become superabundant (compared with those without hydrogen). Both the proto-cavities and the hydrogenated vacancies play important roles in the ensuing cavitation processes. Step 2, when pillars are heated up to 100 °C, proto-cavities in the material grow up by absorbing neighbouring cavities via Ostwald ripening. Step 3, when the critical temperature is approached, the hydrogenated vacancies dissociate to produce H interstitials and bare vacancies, both of which have much higher mobility than hydrogenated vacancies. The interstitial H atoms and bare vacancies can diffuse quickly into the metal–oxide interface, weakening and even breaking more interfacial bonds, a phenomenon that can be termed ‘interfacial hydrogen decohesion’. This creates a diffusion highway along the interface with the exposed naked-metal surface. Step 4, at 200 °C, via this naked-metal surface diffusion, the proto-cavities begin to shrink, with their empty volumes and filling gas quickly sucked away to expand the few giant cavities, and the higher mobility of the naked superabundant vacancies ($\sim 10^4$ atomic p.p.m., or ~ 1 at.%) allows them to diffuse to the interface/surface, contributing further to the growth of the giant cavity.
